**Flood Control Project Maintenance
Levee Inspections**

Spring 2015 Levee Inspection Results

Eastern Honcut Creek

Waterway			Bank	Unit Miles
Unit No. 01 Van Tress			Left	1.46
	Spring (March - May)	Summer (June - August)	(September - November) Fall	Winter (December - February)
Unit Maintenance Rating (Fall Only)				
Date of Inspection	05/26/2015 - 05/26/2015			
DWR Inspector	Michael Pitta			
Accompanied By

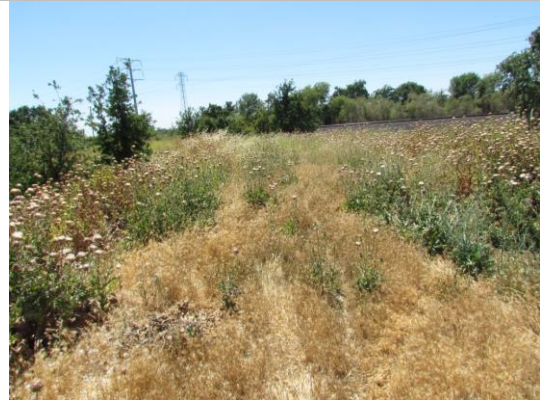
Photo 1 of 1 : SP_2015_NA0006_252_23_20150529_00016.jpg

LM Start	0.07	Rating **	U	Issue No.	23
LM End	0.07	Issue Type +	Ma	Location *	CR
Category	Earthen Levee			GPS Latitude/Longitude	
				Start	End
Item	Vegetation			39.299162 °	39.299162 °
				-121.569041 °	-121.569041 °
DWR ID	DWR_NA0006_01_s_2015_23				
Action/Comments					
Keep the crown roadway free of vegetation.

View of the vegetation on the crown facing upstream.

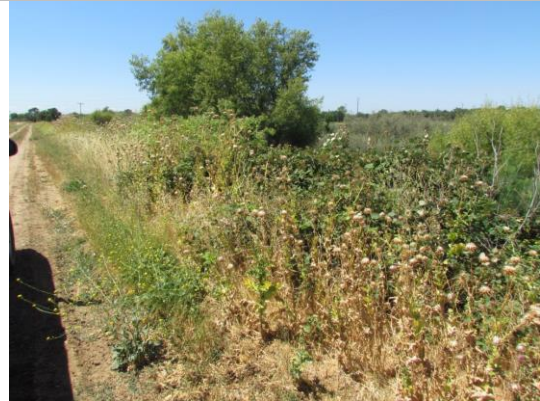
Photo 1 of 1 : SP_2015_NA0006_252_22_20150529_00017.jpg

LM Start	0.22	Rating **	U	Issue No.	22
LM End	0.22	Issue Type +	Ma	Location *	WS
Category	Earthen Levee			GPS Latitude/Longitude	
				Start	End
Item	Vegetation			39.298823 °	39.298823 °
				-121.566421 °	-121.566421 °
DWR ID	DWR_NA0006_01_s_2015_22				
Action/Comments					
Remove the wild growth other than native grasses from the levee slopes.

View of the vegetation on the waterside of the levee facing downstream.

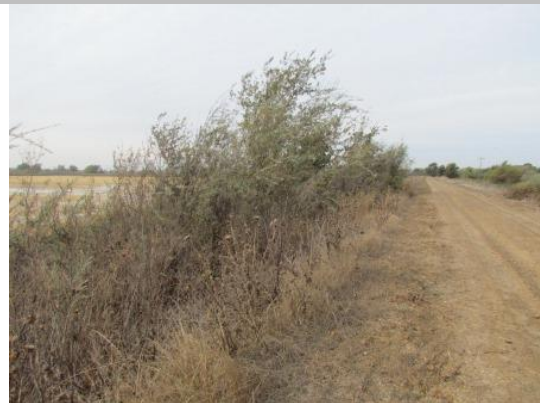
Photo 1 of 1 : SP_2015_NA0006_252_16_20150401_00007.jpg

LM Start	0.22	Rating **	U	Issue No.	16
LM End	0.22	Issue Type +	Ma	Location *	LS
Category	Earthen Levee			GPS Latitude/Longitude	
				Start	End
Item	Trim / Thin Trees			39.298827 °	39.298827 °
				-121.566401 °	-121.566401 °
DWR ID	DWR_NA0006_01_f_2014_16				
Action/Comments					
Thin trees to allow visibility of the ground and room to flood fight. Inspector Comments: Trees should be trimmed up or removed to maintain visibility of landward levee slope.

This photo was taken from the crown facing west looking down the landward levee slope at trees that either need to be trimmed up or removed to provide slope visibility. Fall 2014.

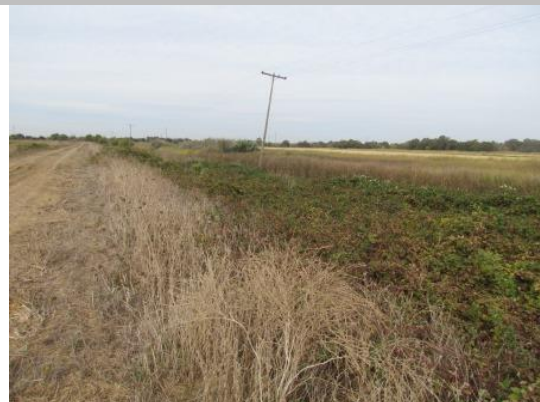
Photo 1 of 1 : SP_2015_NA0006_252_15_20150401_00006.jpg

LM Start	0.45	Rating **	U	Issue No.	15
LM End	0.45	Issue Type +	Ma	Location *	WS
Category	Earthen Levee			GPS Latitude/Longitude	
				Start	End
Item	Vegetation			39.298283 °	39.298283 °
				-121.562021 °	-121.562021 °
DWR ID	DWR_NA0006_01_f_2014_15				
Action/Comments					
Remove the wild growth other than native grasses from the levee slopes.					
Inspector Comments: Berry bushes on waterward levee slope need to be trimmed back.

This photo was taken from the crown facing west looking down the waterward levee slope at berry bushes needing removal. Fall 2014.

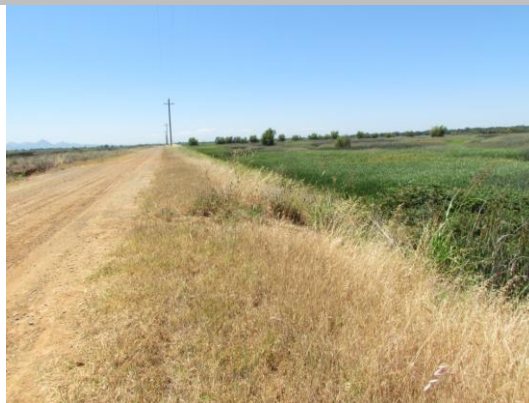
Photo 1 of 1 : SP_2015_NA0006_252_3_20150529_00018.jpg

LM Start	0.57	Rating **	U	Issue No.	3
LM End	1.46	Issue Type +	Ma	Location *	WS
Category	Earthen Levee			GPS Latitude/Longitude	
				Start	End
Item	Vegetation			39.298019 °	39.295255 °
				-121.559940 °	-121.546436 °
DWR ID	DWR_NA0006_01_s _ 2012_3				
Action/Comments					
Remove the wild growth other than native grasses from the levee slopes.

View of the vegetation on the waterside of the levee facing downstream.

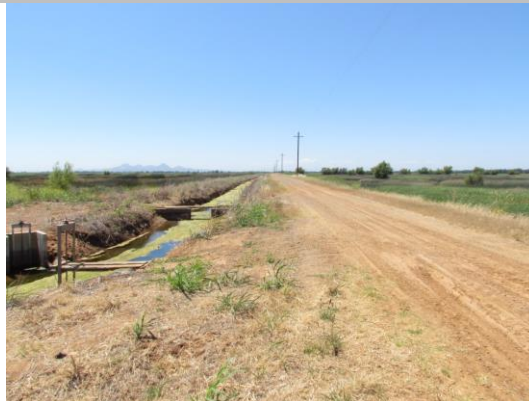
Photo 1 of 1 : SP_2015_NA0006_252_1_20150529_00019.jpg

LM Start	0.57	Rating **	M	Issue No.	1
LM End	1.46	Issue Type +	Ma	Location *	LS
Category	Earthen Levee			GPS Latitude/Longitude	
				Start	End
Item	Vegetation			39.298018 °	39.295254 °
				-121.559940 °	-121.546437 °
DWR ID	DWR_NA0006_01_s _ 2012_1				
Action/Comments					
Remove the wild growth other than native grasses from the levee slopes.

View of the vegetation on the landside of the levee facing downstream.

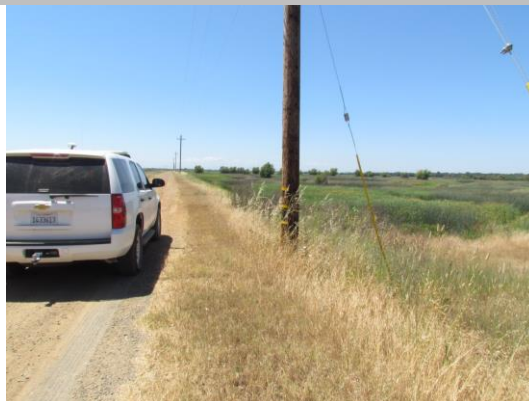
Photo 1 of 1 : SP_2015_NA0006_252_17_20150529_00013.jpg

LM Start	0.66	Rating **	M	Issue No.	17
LM End	1.45	Issue Type +	En	Location *	WS
Category	Earthen Levee			GPS Latitude/Longitude	
				Start	End
Item	Encroachments			39.297629 °	39.295257 °
				-121.558337 °	-121.546579 °
DWR ID	DWR_NA0006_01_s _ 2015_17				
Action/Comments					
Pole

View of the pole on the waterside of the levee facing downstream.

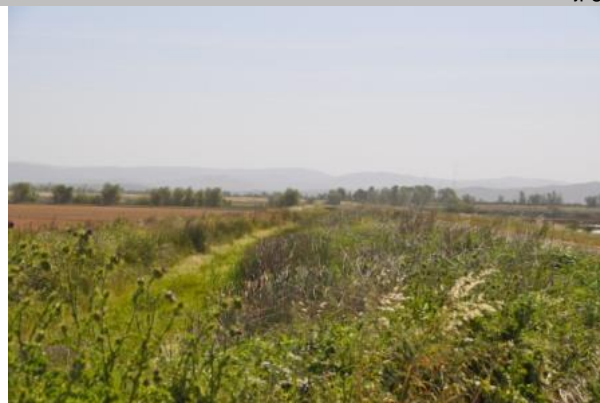
Photo 1 of 1 : SP_2015_NA0006_252_5_20150401_00004.jpg

LM Start	0.67	Rating **	M	Issue No.	5
LM End	1.17	Issue Type +	En	Location *	WS
Category	Earthen Levee			GPS Latitude/Longitude	
				Start	End
Item	Encroachments			39.297472 °	39.295134 °
				-121.558327 °	-121.551805 °
DWR ID	DWR_NA0006_01_s _ 2012_5				
Action/Comments					
Ditch

Toe ditch parallel to levee @ w/s toe. Heavy vegetation in ditch.

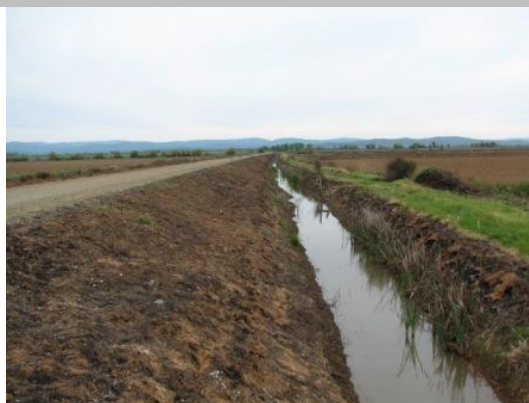
Photo 1 of 1 : SP_2015_NA0006_252_8_20150401_00005.jpg

LM Start	0.67	Rating **	M	Issue No.	8
LM End	1.44	Issue Type +	En	Location *	LS
Category	Earthen Levee			GPS Latitude/Longitude	
				Start	End
Item	Encroachments			39.297472 °	39.295261 °
				-121.558327 °	-121.546759 °
DWR ID	DWR_NA0006_01_s _ 2012_8				
Action/Comments					
Ditch

Levee mile 0.85, this photo is looking upstream at a ditch on the landside toe.
